Lombard Field

Town of Barnstable ADA Transition Plan

September 2021

Institute for Human Centered Design

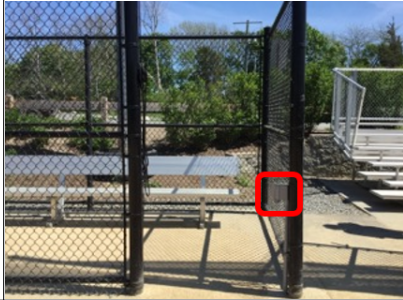
Accessibility issues with exterior accessible routes include walkways with cross slopes that are greater than the maximum allowed at the route to the bleachers. In addition, the electrical boxes at the entrance of both team seating areas act as protruding objects.

| ID | Location | Floor | Room | Element | Type | Photo | Issues | Current Measure | Recommendations | Quantity | Price | Cost Estimation |
|---|--|---|---|---|---|--|--|---|---|---|---|---|
| 1 | Dugouts | Ext. | | Exterior Access Route | Exterior | | Route obstructed by protruding objects | 28" | Provide a cane-detectable barrier at the electric boxes located at both dugouts. | 2 | 306 | \$612 |

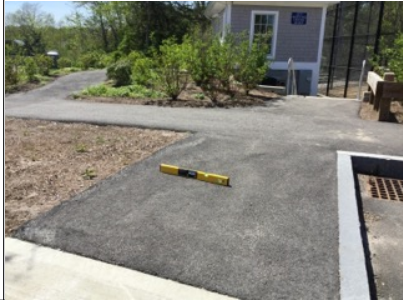
| ID | Location | Floor | Room | Element | Type | Photo | Issues | Current Measure | Recommendations | Quantity | Price | Cost Estimation |
|---|--|---|---|---|---|--|--|---|---|---|---|---|
| 2 | Route From Parking Lot to Bleachers, Dugout, and Score Box | Ext. | | Exterior Access Route | Walkway | | Cross slope > 1:50 (2.00%) | 3.2% | Reduce cross slope to be no steeper than 1:50 (2.00%). (Cost for 4' by 10' of asphalt to reduce cross slope.) | 1 | 400 | \$400 |

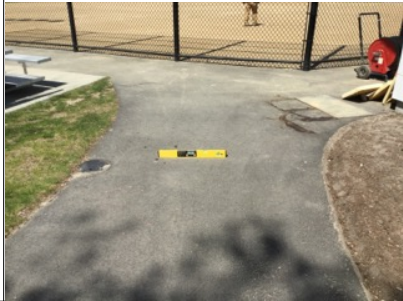
| ID | Location | Floor | Room | Element | Type | Photo | Issues | Current Measure | Recommendations | Quantity | Price | Cost Estimation |
|---|--|---|---|---|---|--|--|---|---|---|---|---|
| 3 | Route From Parking Lot to Bleachers and Dugout | Ext. | | Exterior Access Route | Walkway | | Cross slope > 1:50 (2.00%) | 2.8% | Reduce cross slope to be no steeper than 1:50 (2.00%). (Cost for 4' by 10' of asphalt to reduce cross slope.) | 1 | 600 | \$600 |

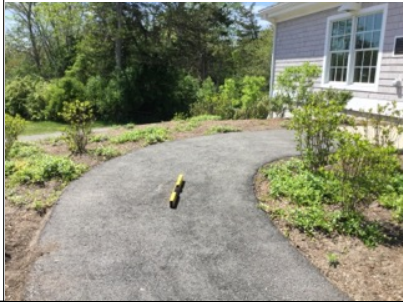
| ID | Location | Floor | Room | Element | Type | Photo | Issues | Current Measure | Recommendations | Quantity | Price | Cost Estimation |
|---|--|---|---|---|---|--|--|---|---|---|---|---|
| 4 | Route From Parking Lot to Bleachers, Dugout, and Score Box | Ext. | | Exterior Access Route | Walkway | | Running slope > 1:20 (5%) | 7.4% | Reduce running slope to be no steeper than 1:20 (5%). (Cost for 4' by 15' of asphalt to reduce running slope.) | 1 | 600 | \$600 |

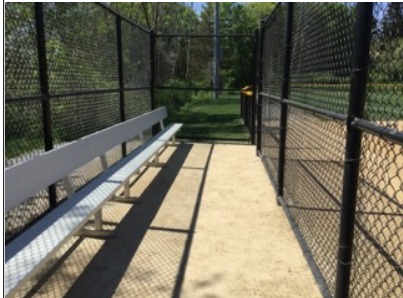
| ID | Location | Floor | Room | Element | Type | Photo | Issues | Current Measure | Recommendations | Quantity | Price | Cost Estimation |
|---|--|---|---|---|---|--|--|---|---|---|---|---|
| 5 | Dugouts | Ext. | | Field | Baseball | | Accessible spaces are not provided at team seating | - | Provide a 36" x 48" clear floor space at both team seating dugouts. | 2 | Labor | \$0 |

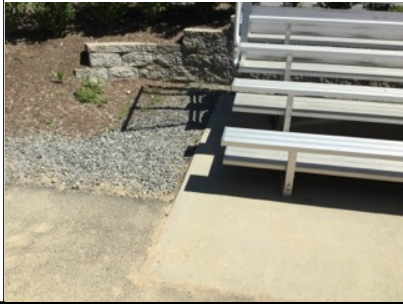
| ID | Location | Floor | Room | Element | Type | Photo | Issues | Current Measure | Recommendations | Quantity | Price | Cost Estimation |
|---|---|---|---|---|---|--|---|---|--|---|---|---|
| 6 | Bleachers at Right Side of Home Plate | Ext. | | Field | Baseball | | Accessible spaces not provided at sidelines seating | - | Provide a 36" x 48" firm and stable clear floor space at sidelines seating with a max. slope of 2.00% in all directions. (Cost for 3' X 4' of asphalt.) | 1 | 120 | \$120 |

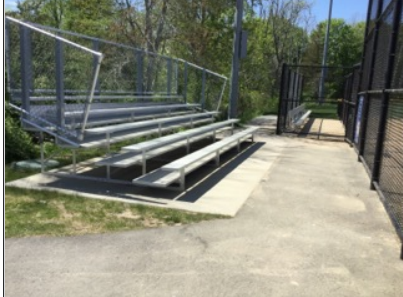
| ID | Location | Floor | Room | Element | Type | Photo | Issues | Current Measure | Recommendations | Quantity | Price | Cost Estimation |
|---|---|---|---|---|---|--|---|---|--|---|---|---|
| 7 | Bleachers at Left Side of Home Plate | Ext. | | Bleachers | N/A | | Seating spaces < 36" x 48" (single space) | 12" | Provide a 36" x 48" firm and stable clear floor space at sidelines seating with a max. slope of 2.00% in all directions. (Cost for 3' X 4' of asphalt.) | 1 | 120 | \$120 |
