## Osterville Community Center

## Town of Barnstable ADA Transition Plan

Institute for Human Centered Design

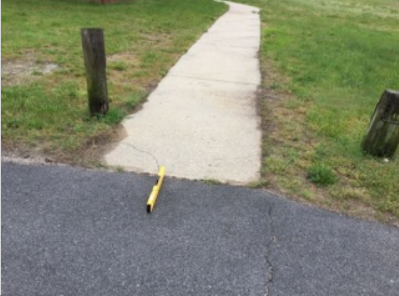
Running slope > 1:20 (5%)	7.9%	Reduce running slope to be no steeper than 1:20 (5%).	1	-	\$0
2	Route to Main Entrance	Ext.		Exterior Access Route	Walkway

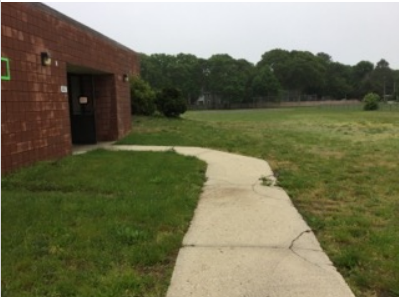
Route not maintained in operable working condition	-	Repair surface to ensure the accessible route is maintained in operable working condition.	1	-	\$0
3	Emergency Exit - Northeast Side	Ext.		Exterior Access Route

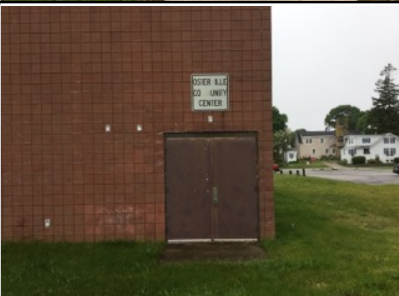
Accessible route not provided	-	Ensure an accessible route is provided.	1	-	\$0
4	Emergency Exit - Northwest Side	Ext.		Exterior Access Route	Exterior

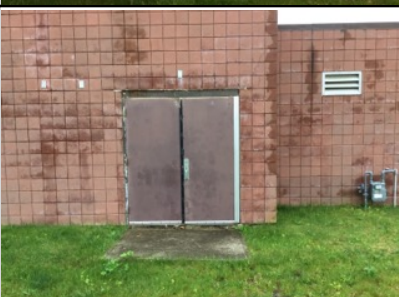
Accessible route not provided	-	Ensure an accessible route is provided.	1	-	\$0
5	To Baseball Field South From Playground	Ext.		Exterior Access Route

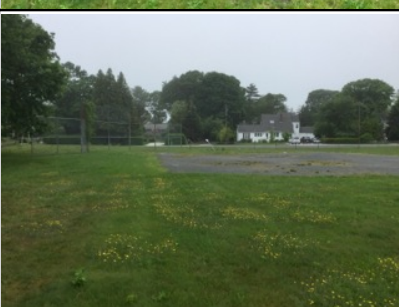
Accessible route not provided	-	Ensure an accessible route is provided to the boundary of sport activity.	1	-	\$0

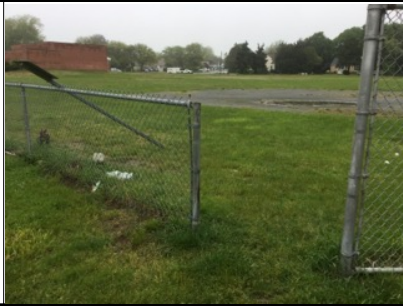
Accessible route not provided	-	Ensure baseball field is connected to an accessible route.	1	-	\$0
<b>Entrance</b>												
7	Main Entrance	Ext.		Entrance	Main Entrance

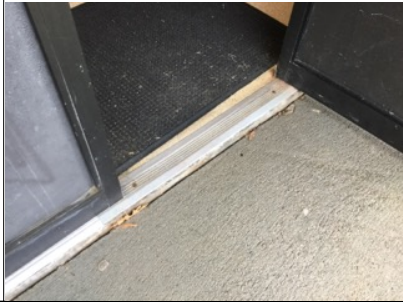
Threshold not beveled Threshold > 1/2" high	- 1.75"	Bevel the threshold. Alter threshold to be 1/2" high max.	1	-	\$0
<b>Emergency Exit</b>												
8	Emergency Exit - Northeast Side	Ext.		Emergency Exit	N/A

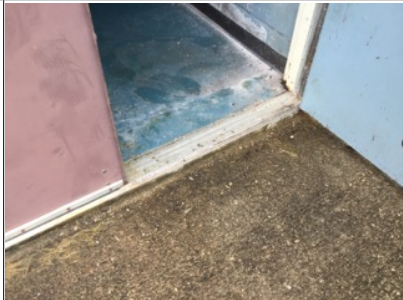
Threshold > 1/2" high Threshold not beveled	2" -	Alter the threshold to be 1/2" high max. Bevel the threshold.	1	-	\$0
9	Emergency Exit - Northwest Side	Ext.		Emergency Exit	N/A

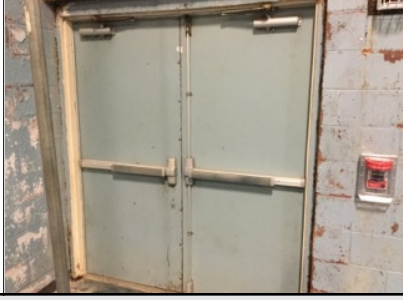
Door requires > 15 lbs. of force to open	17 lbs.	Adjust closers of exterior doors so doors do not require more than 15 pounds of force.  Note: Fire doors shall have a minimum opening force allowable by the appropriate administrative authority.	1	-	\$0

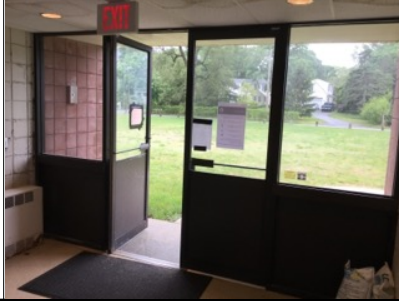
Tactile exit sign not provided	-	Ensure tactile exit signs with raised characters and braille are provided at exit doors. Mount signs between 48"- 60" above the finished floor located on the latch side of the door. If the exit sign is replaced with an illuminated exit sign, provide an illuminated International Symbol of Accessibility (ISA).	1	-	\$0
12	Emergency Exit - Northeast Side	1		Means of Egress	N/A

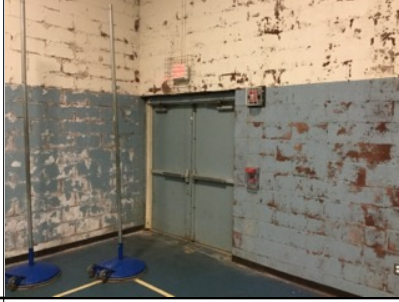
Tactile exit sign not provided Directional sign to accessible emergency exit not provided	- -	Ensure a tactile exit sign with raised characters and braille is provided at exit door. Mount sign between 48"- 60" above the finished floor located on the latch side of the door. Provide a directional sign indicating the location of the nearest accessible emergency exit.	1	-	\$0

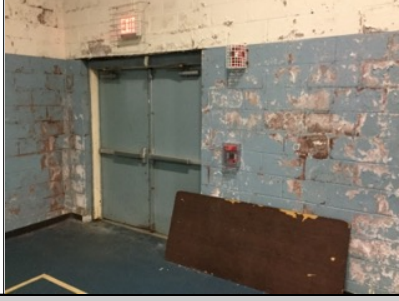
13	Emergency Exit - Northwest Side	1		Means of Egress	N/A

Tactile exit sign not provided Directional sign to accessible emergency exit not provided	- -	Ensure a tactile exit sign with raised characters and braille is provided at exit door. Mount sign between 48"- 60" above the finished floor located on the latch side of the door. Provide a directional sign indicating the location of the nearest accessible emergency exit.	1	-	\$0
<b>Interior Access Route</b>												
14	Meeting Room	1		Interior Access Route

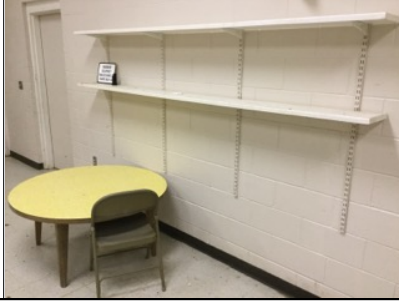
Obstructed by protruding objects	10.25"	Relocate shelves so they do not protrude into the circulation path.	1	-	\$0
<b>Doors, Doorways, &amp; Gates</b>												
15	Vestibule	1		Doors, Doorways, & Gates	Meeting Room

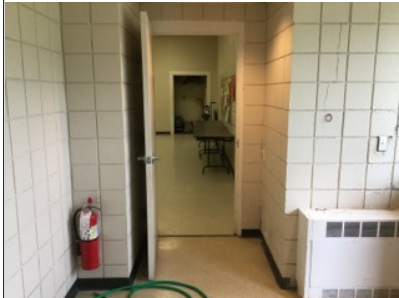
Maneuvering clearance(s) not provided	10.5"	Provide an automatic door opener.	1	-	\$0

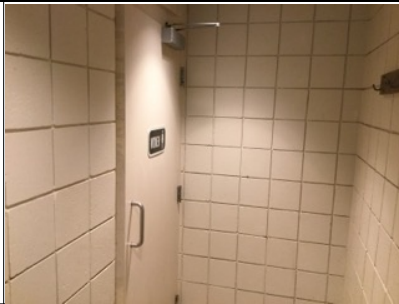
Maneuvering clearance(s) not provided		Provide an automatic door opener.	1	-	\$0
17	Women's Toilet Room	1		Doors, Doorways, & Gates	Toilet Room

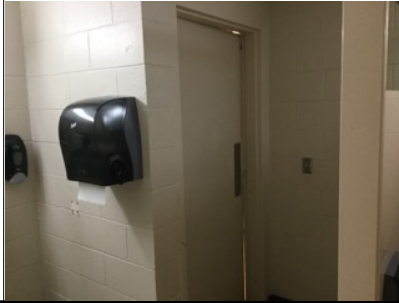
Maneuvering clearance(s) not provided	5"	Provide an automatic door opener.	1	-	\$0
18	Men's Toilet Room	1		Doors, Doorways, & Gates	Toilet Room

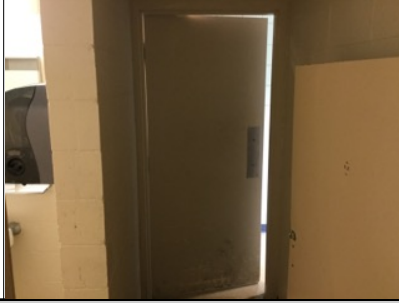
Door requires > 5 lbs. of force to open	18 lbs.	Adjust closers so doors do not require more than 5 pounds of force to open.	1	-	\$0
<b>Signage</b>												
19	Men's Toilet Room	1		Signage	Designation

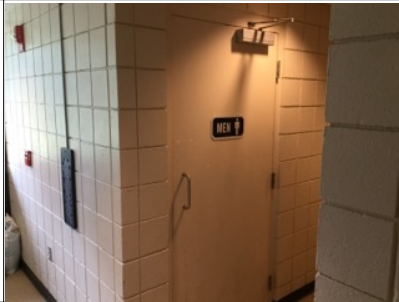
Raised characters not provided on sign Braille not provided on sign Sign not located on the latch side of the door	- - -	Provide text with raised characters duplicated in braille on sign. Locate sign at permanent rooms alongside the door on the latch side.	1	-	\$0

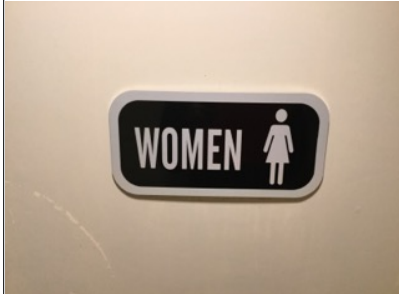
20	Women's Toilet Room	1		Signage

Raised characters not provided on sign Braille not provided on sign Sign not located on the latch side of the door	- - -	Provide text with raised characters duplicated in braille on sign. Locate sign at permanent rooms alongside the door on the latch side.	1	-	\$0

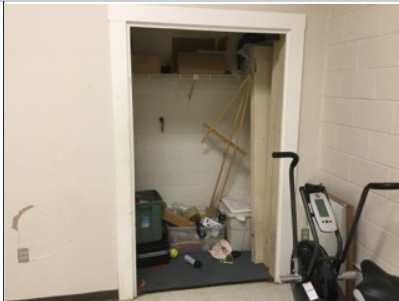
Reach < 15" or > 48"(forward/side approach)	68.1"	Relocate clothes rod 48" above the finished floor.	1	-	\$0
22	Hallway to Toilet Rooms	1		Operable Parts	Clothes Rod/Hooks

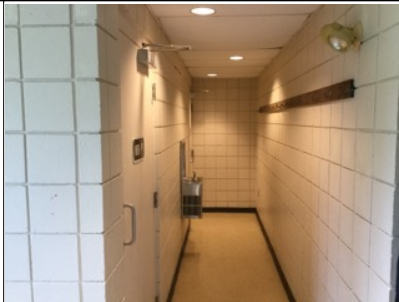
Reach < 15" or > 48"(forward/side approach)	71"	Provide at least one hook mounted 48" above the finished floor.	1	-	\$0
<b>Dining or Work Surfaces</b>												
23	Meeting Room	1		Dining or Work Surfaces	Work Surface

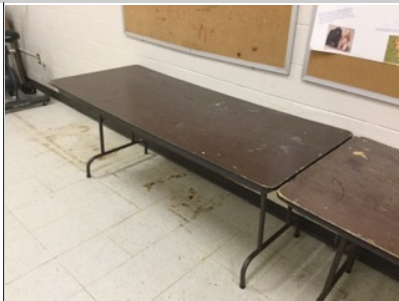
Knee or toe clearance not provided	-	Provide at least 1 dining or work surface with 27" min. knee and toe clearance.	1	-	\$0
<b>Exterior Benches</b>												
24	Playground	Ext.		Exterior Benches

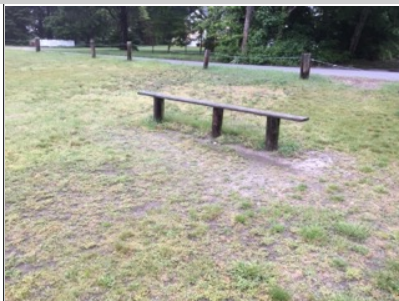
No accessible route to one bench in area	-	Locate bench on an accessible route.	1	-	\$0
<b>Toilet &amp; Bathing Rooms</b>

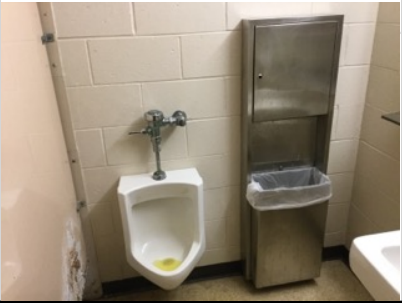
Turning space not provided	-	Renovate toilet room to provide turning space.	1	-	\$0
26	Women's Toilet Room	1		Overall Access	Toilet Room

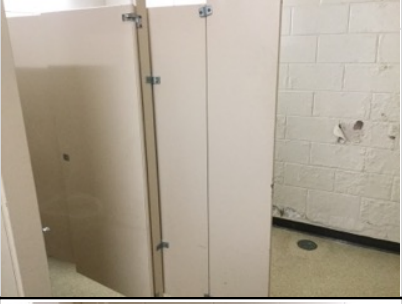
Turning space not provided	-	Renovate toilet room to provide turning space.	1	-	\$0
27	Women's Toilet Room & Men's Toilet Room	1		Overall Access	Toilet Room

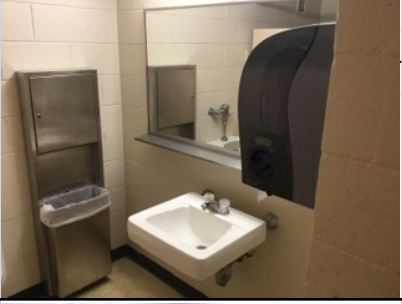
Toe or knee clearances not provided Faucet is not operable with a closed fist Plumbing underneath is exposed	24.3" - -	Provide at least one lavatory with knee and toe clearance positioned for a forward approach. Provide a faucet that can be operable with one hand and not require tight grasping, pinching, or twisting of the wrist for at least one lavatory. Insulate or otherwise configure pipes to prevent contact for at least one lavatory.	1	-	\$0

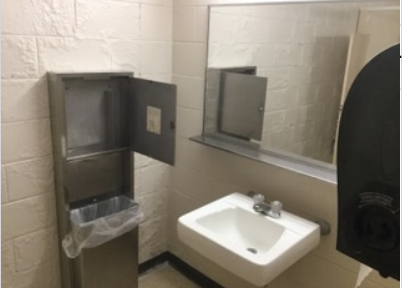
29	Women's Toilet Room	1		Lavatory	N/A

Toe or knee clearances not provided Faucet is not operable with a closed fist Plumbing underneath is exposed	24.6" - -	Provide at least one lavatory with knee and toe clearance positioned for a forward approach. Provide a faucet that can be operable with one hand and not require tight grasping, pinching, or twisting of the wrist for at least one lavatory. Insulate or otherwise configure pipes to prevent contact for at least one lavatory.	1	-	\$0

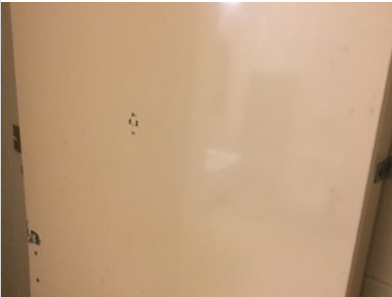
Door has non-compliant hardware Door has malfunctioning self-closing hinge	- -	Provide hardware that can be operable with one hand and not require tight grasping, pinching, or twisting of the wrist. Repair hinge.	1	-	\$0
31	Women's Toilet Room	1		Toilet Compartment

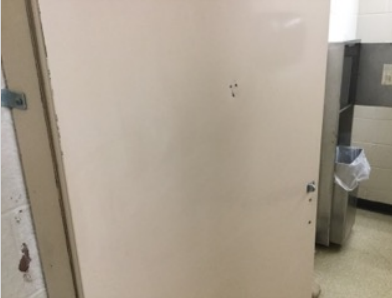
Door has non-compliant hardware Door has malfunctioning self-closing hinge	- -	Provide hardware that can be operable with one hand and not require tight grasping, pinching, or twisting of the wrist. Repair hinge.	1	-	\$0
32	Women's Toilet Room	1		Toilet Compartment	Accessible Compartment

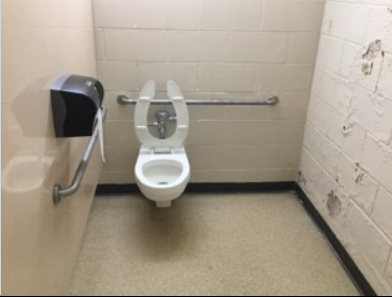
Side or rear grab bar < 33" or >36" high Flush control not on open side Non-compliant toilet paper dispenser Clearance at toilet < 60" clear width Centerline < or > 18" (MAAB)	30.4" - - 57.8" 15.8"	Locate grab bars between 33"- 36" above the finished floor. Provide the flush control on the open side of the toilet (transfer side). Relocate toilet paper so that it is 24" min. high, located under the grab bar, and between 7" and 9" from the front of the toilet. Provide a wheelchair accessible compartment that is 60" wide min. Relocate toilet so the centerline is 18" from the side wall.	1	-	\$0

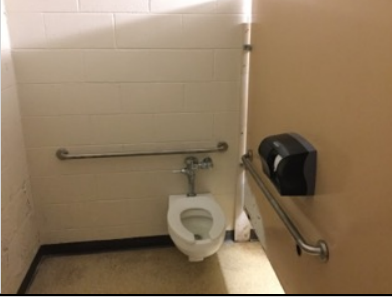
33	Men's Toilet Room	1		Toilet Compartment	Accessible Compartment

Side or rear grab bar < 33" or >36" high Non-compliant toilet paper dispenser Clearance at toilet < 60" clear width Centerline < or > 18" (MAAB)	30.9" - 55.9" 15.6"	Locate grab bars between 33"- 36" above the finished floor. Relocate toilet paper so that it is 24" min. high, located under the grab bar, and between 7" and 9" from the front of the toilet. Provide a wheelchair accessible compartment that is 60" wide min. Relocate toilet so the centerline is 18" from the side wall.	1	-	\$0
<b>Dispensers</b>												
34	Men's Toilet Room	1		Dispensers	Paper Towel Dispenser

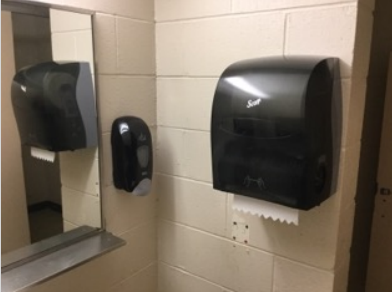
Not operable with a closed fist Dispenser acts as a protruding object	- -	Provide a dispenser that can be operable with one hand and not require tight grasping, pinching, or twisting of the wrist. Relocate dispenser out of the circulation path.	1	-	\$0

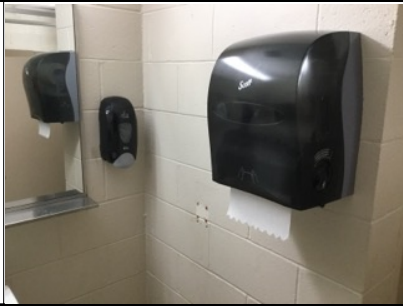
Not operable with a closed fist Dispenser acts as a protruding object	- 10"	Provide a dispenser that can be operable with one hand and not require tight grasping, pinching, or twisting of the wrist. Relocate dispenser out of the circulation path.	1	-	\$0
<b>Additional Access</b>												
<b>Drinking Fountains</b>												
36	Hallway to Women's Toilet Room	1		Drinking Fountains	High

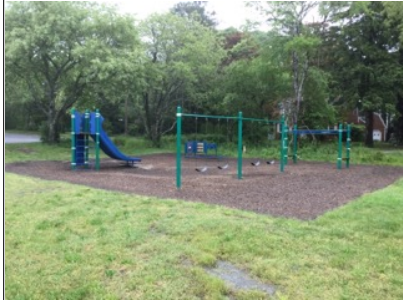
Accessible route not provided to playground Accessible route not provided around playground Surface not stable, firm, and slip-resistant	- - -	Install an accessible route to and around the playground. Repair surface and ensure that surface is firm, stable and slip-resistant (to areas around play components).	1	-	\$0

Accessibility issues at the playground include lack of an accessible route to and around the playground and lack of an impact-attenuating accessible surface to, under and around the play elements within the playground. Also, of concern is the lack of an accessible route that connects all the exterior amenities. If the baseball field is used again an accessible route to the boundary of sport activity must be provided.

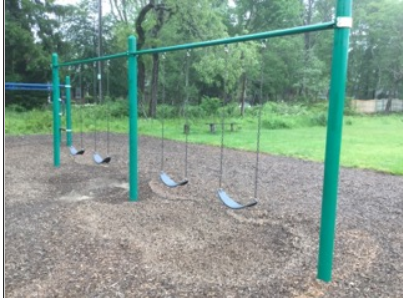
38	Playground	Ext.		Play Areas	N/A

Surface not stable, firm, and slip-resistant Play areas not maintained in operable working condition	- -	Repair surface and ensure that surface is firm, stable and slip-resistant (to areas around play components). Ensure play area is maintained in operable working condition.	1	-	\$0

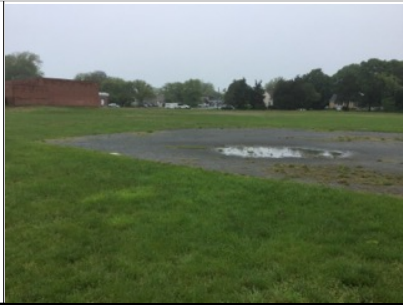
No accessible route to all areas of sport activity	-	Ensure an accessible route is provided to all areas of sport activity.	1	-	\$0
<b>Best Practice</b>												
<b>Gate</b>												
40	Entry to Tennis Courts	Ext.		Gate	N/A

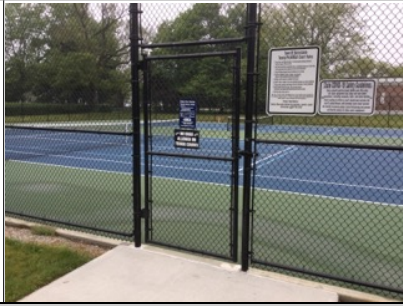
Recommended providing a gate surface within 10" of the ground on the push side of both gates of the tennis court.	1	-	\$0
<b>Signage</b>												
41	Meeting Room to Gymnasium	1		Signage	N/A

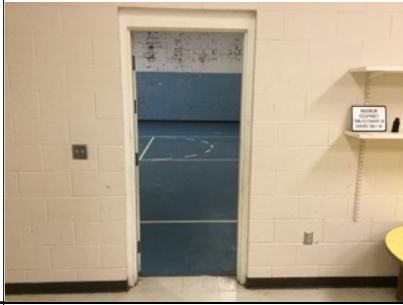
Recommend providing a designation sign at this location.	1	-	\$0
42	Hallway to Gymnasium	1		Signage	N/A				Recommend providing directional sign to the gymnasium at this location.	1	-	\$0

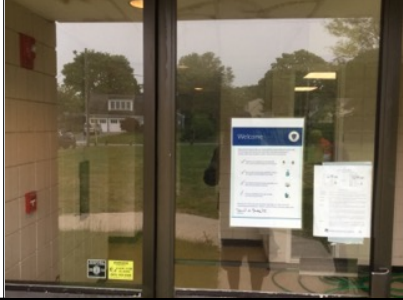
Recommend relocating information to avoid glare.	1	-	\$0
<b>Kitchenette</b>												
44	Meeting Room	1		Kitchenette	N/A

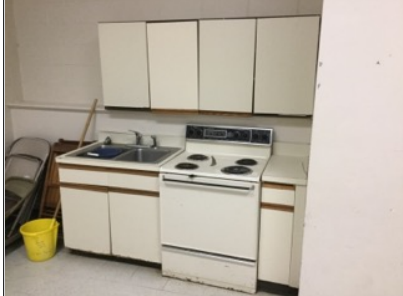
If program participants or volunteers use the kitchen, provide an accessible sink and an accessible stove (with knee and toe clearance). Ensure stove has controls that do not required reaching across burners.	1	-	\$0
