# School Administration Building

## Town of Barnstable ADA Transition Plan

June 2021

Institute for Human Centered Design

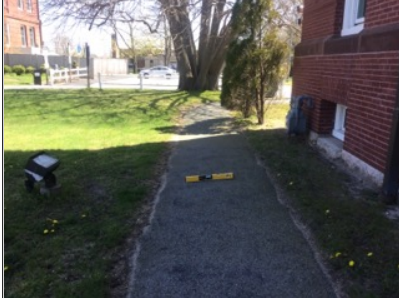
| ID | Location | Floor | Room | Element | Type | Photo | Issues | Current Measure | Recommendations | Quantity | Price | Cost Estimation |
|---|--|---|---|---|---|--|---|---|--|---|---|---|
| 1 | Left Path to Car Parking - Outside Entrance/ Exit From Village Green | Ext. | | Exterior Access Route | Walkway | | Cross slope > 1:50 (2.00%) | 5.2% | Reduce cross slope to be no steeper than 1:50 (2.00%).<br><br>(Cost based on asphalt to reduce slope.) | 1 | 240 | \$240 |

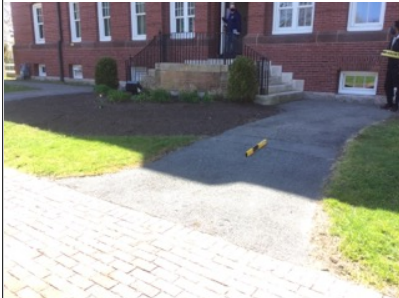
| ID | Location | Floor | Room | Element | Type | Photo | Issues | Current Measure | Recommendations | Quantity | Price | Cost Estimation |
|---|--|---|---|---|---|--|---|---|--|---|---|---|
| 2 | Right Path - Outside Entrance/ Exit From Village Green | Ext. | | Exterior Access Route | Walkway | | Running slope > 1:20 (5%) | 13.4% | Reduce running slope to be no steeper than 1:20 (5%).<br><br>(Cost based on asphalt to reduce slope.) | 1 | 240 | \$240 |

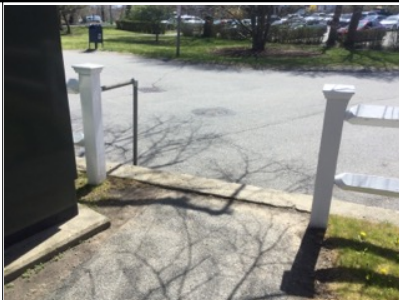
| ID | Location | Floor | Room | Element | Type | Photo | Issues | Current Measure | Recommendations | Quantity | Price | Cost Estimation |
|---|--|---|---|---|---|--|---|---|--|---|---|---|
| 3 | Left Path to Car Parking - Outside Entrance/ Exit From Village Green | Ext. | | Exterior Access Route | Walkway | | Level changes > 1/4" | 1" | Alter change in level to be 1/4" high max.<br><br>(Cost based on an asphalt patch.) | 1 | 160 | \$160 |

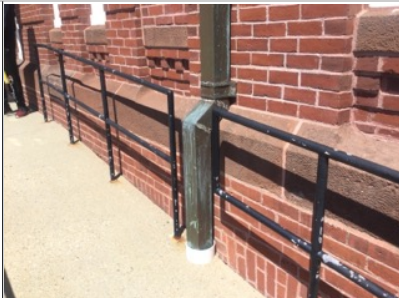
| ID | Location | Floor | Room | Element | Type | Photo | Issues | Current Measure | Recommendations | Quantity | Price | Cost Estimation |
|---|--|---|---|---|---|--|---|---|--|---|---|---|
| 4 | Accessible Entrance/ Exit | Ext. | | Exterior Ramp | N/A | | Handrails not continuous where required | - | Provide continuous handrails around drain spout. | 1 | 142 | \$142 |

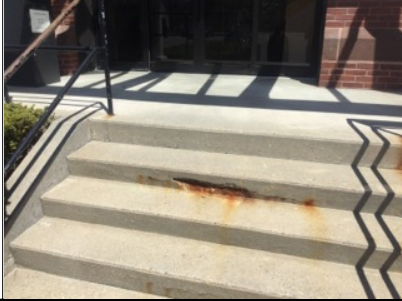
| ID | Location | Floor | Room | Element | Type | Photo | Issues | Current Measure | Recommendations | Quantity | Price | Cost Estimation |
|---|---|---|---|---|---|--|---|---|---|---|---|---|
| 5 | Accessible Entrance/ Exit | Ext. | | Exterior Stair | N/A | | Not maintained in operable working condition | - | Ensure stairs are maintained in operable working condition.<br><br>(Cost based on a concrete patch.) | 1 | 256 | \$256 |

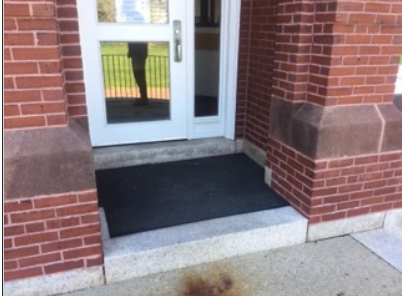
| ID | Location | Floor | Room | Element | Type | Photo | Issues | Current Measure | Recommendations | Quantity | Price | Cost Estimation |
|---|---|---|---|---|---|--|---|---|---|---|---|---|
| 6 | Entrance/ Exit From Village Green | Ext. | | Entrance | Secondary Entrance | | Directional sign to accessible entrance not provided | - | Provide a directional sign indicating the location of the nearest accessible entrance. | 1 | 346 | \$346 |

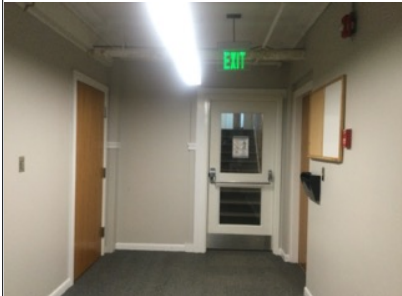
| ID | Location | Floor | Room | Element | Type | Photo | Issues | Current Measure | Recommendations | Quantity | Price | Cost Estimation |
|---|---|---|---|---|---|--|---|---|---|---|---|---|
| 7 | To Exit Stair Facing Main Street | B | | Emergency Exit | N/A | | Tactile sign not provided at exit | - | Provide tactile exit signs with raised characters and braille at exit doors. Mount signs between 48"- 60" above the finished floor located on the latch side of the door. | 1 | 232 | \$232 |

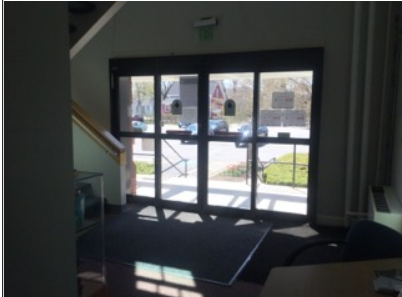
| ID | Location | Floor | Room | Element | Type | Photo | Issues | Current Measure | Recommendations | Quantity | Price | Cost Estimation |
|---|---|---|---|---|---|--|---|---|---|---|---|---|
| 8 | Accessible Entrance/ Exit | 1 | | Emergency Exit | N/A | | Tactile sign not provided at exit<br>Directional sign to accessible emergency exit not provided | | Provide tactile exit signs with raised characters and braille at exit doors. Mount signs between 48"- 60" above the finished floor located on the latch side of the door. | 1 | 232 | \$232 |

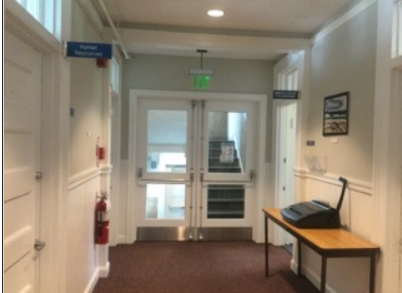
| ID | Location | Floor | Room | Element | Type | Photo | Issues | Current Measure | Recommendations | Quantity | Price | Cost Estimation |
|---|---|---|---|---|---|--|---|---|---|---|---|---|
| 9 | Exit Stair Facing Main Street | 1 | | Emergency Exit | N/A | | Tactile sign not provided at exit<br>Directional sign to accessible emergency exit not provided | -<br>- | Provide tactile exit signs with raised characters and braille at exit doors. Mount signs between 48"- 60" above the finished floor located on the latch side of the door.<br>Provide a directional sign indicating the location of the nearest accessible emergency exit. | 1 | 232 | \$232 |

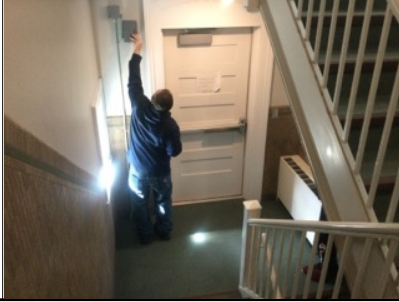
| ID | Location | Floor | Room | Element | Type | Photo | Issues | Current Measure | Recommendations | Quantity | Price | Cost Estimation |
|---|---|---|---|---|---|--|---|---|---|---|---|---|
| 10 | Exit Facing Main Street | .5 | | Emergency Exit | N/A | | Tactile sign not provided at exit<br>Directional sign to accessible emergency exit not provided | -<br>- | Provide tactile exit signs with raised characters and braille at exit doors. Mount signs between 48"- 60" above the finished floor located on the latch side of the door.<br>Provide a directional sign indicating the location of the nearest accessible emergency exit. | 1 | 232 | \$232 |

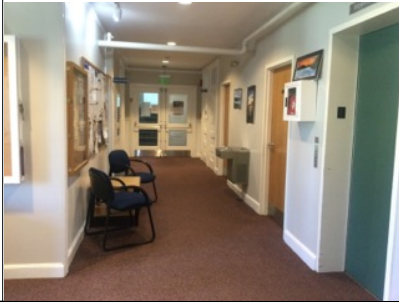
| ID | Location | Floor | Room | Element | Type | Photo | Issues | Current Measure | Recommendations | Quantity | Price | Cost Estimation |
|---|---|---|---|---|---|--|---|---|---|---|---|---|
| 11 | Near Elevator | 1 | | Interior Access Route | N/A | | Obstructed by protruding objects | 54.4" | Relocate defibrillator or provide a cane-detectable barrier 27" max. above the finished floor. | 1 | 306 | \$306 |

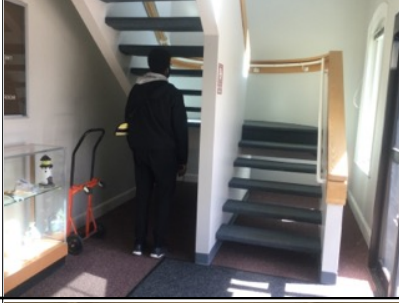
| ID | Location | Floor | Room | Element | Type | Photo | Issues | Current Measure | Recommendations | Quantity | Price | Cost Estimation |
|---|---|---|---|---|---|--|---|---|---|---|---|---|
| 12 | Front Stair Near Accessible Entrance | 2 | | Interior Access Route | N/A | | Obstructed by protruding objects | 74" | Provide a cane-detectable barrier.<br><br>(Cost based on a pipe rail under stair positioned 27" max. above the finished floor.) | 1 | 960 | \$960 |

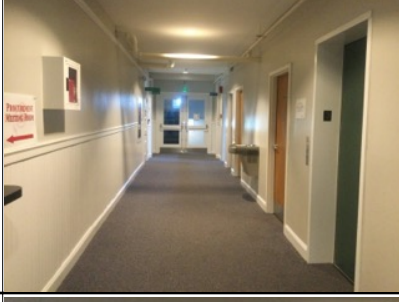
| ID | Location | Floor | Room | Element | Type | Photo | Issues | Current Measure | Recommendations | Quantity | Price | Cost Estimation |
|---|---|---|---|---|---|--|---|---|---|---|---|---|
| 13 | Near Elevator | 3 | | Interior Access Route | N/A | | Obstructed by protruding objects | 6" | Relocate defibrillator or provide a cane-detectable barrier 27" max. above the finished floor. | 1 | 306 | \$306 |

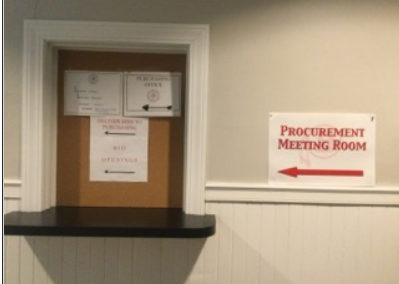
| ID | Location | Floor | Room | Element | Type | Photo | Issues | Current Measure | Recommendations | Quantity | Price | Cost Estimation |
|---|---|---|---|---|---|--|---|---|---|---|---|---|
| 14 | Administrative Services | 3 | | Interior Access Route | N/A | | Obstructed by protruding objects | 8.5" | Provide a cane-detectable barrier. | 1 | 306 | \$306 |

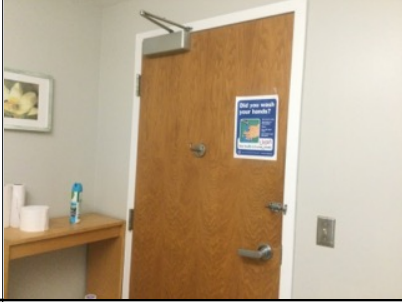
| ID | Location | Floor | Room | Element | Type | Photo | Issues | Current Measure | Recommendations | Quantity | Price | Cost Estimation |
|---|---|---|---|---|---|--|--|---|--|---|---|---|
| 15 | Women's Toilet Room | 3 | | Doors, Doorways, & Gates | Toilet Room | | Hardware not operable with a closed fist | - | Provide hardware that can be operable with one hand and not require tight grasping, pinching, or twisting of the wrist.<br><br>(Fix door latch, remove dead bolt.) | 1 | 484 | \$484 |

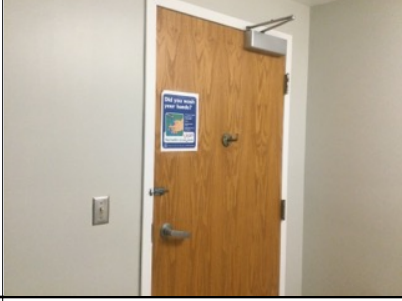
| ID | Location | Floor | Room | Element | Type | Photo | Issues | Current Measure | Recommendations | Quantity | Price | Cost Estimation |
|---|---|---|---|---|---|--|--|---|--|---|---|---|
| 16 | Men's Toilet Room | 3 | | Doors, Doorways, & Gates | Toilet Room | | Hardware not operable with a closed fist | - | Provide hardware that can be operable with one hand and not require tight grasping, pinching, or twisting of the wrist. | 1 | 484 | \$484 |

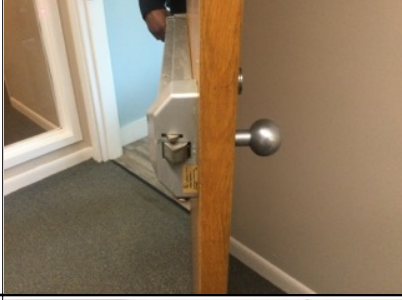
| ID | Location | Floor | Room | Element | Type | Photo | Issues | Current Measure | Recommendations | Quantity | Price | Cost Estimation |
|---|---|---|---|---|---|--|--|---|--|---|---|---|
| 17 | Conference Room | B | | Doors, Doorways, & Gates | Meeting Room | | Hardware not operable with a closed fist | - | Provide hardware that can be operable with one hand and not require tight grasping, pinching, or twisting of the wrist. | 1 | 484 | \$484 |

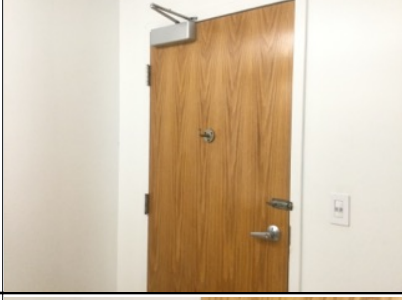
| ID | Location | Floor | Room | Element | Type | Photo | Issues | Current Measure | Recommendations | Quantity | Price | Cost Estimation |
|---|---|---|---|---|---|--|--|---|--|---|---|---|
| 18 | Women's Toilet Room | B | | Doors, Doorways, & Gates | Toilet Room | | Hardware not operable with a closed fist | - | Provide hardware that can be operable with one hand and not require tight grasping, pinching, or twisting of the wrist.<br><br>(Fix door latch, remove dead bolt.) | 1 | 484 | \$484 |

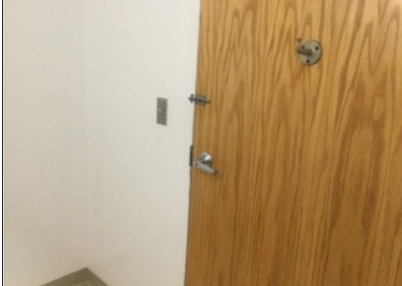
| ID | Location | Floor | Room | Element | Type | Photo | Issues | Current Measure | Recommendations | Quantity | Price | Cost Estimation |
|---|---|---|---|---|---|--|--|---|--|---|---|---|
| 19 | Men's Toilet Room | B | | Doors, Doorways, & Gates | Toilet Room | | Hardware not operable with a closed fist | - | Provide hardware that can be operable with one hand and not require tight grasping, pinching, or twisting of the wrist. | 1 | 484 | \$484 |

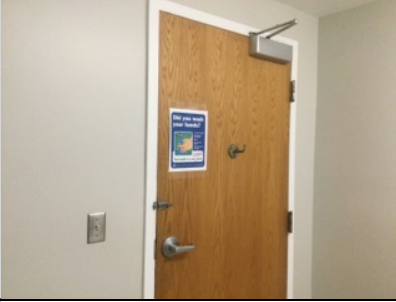
| ID | Location | Floor | Room | Element | Type | Photo | Issues | Current Measure | Recommendations | Quantity | Price | Cost Estimation |
|---|---|---|---|---|---|--|---|---|--|---|---|---|
| 20 | Men's Toilet Room | 1 | | Doors, Doorways, & Gates | Toilet Room | | Door requires > 5 lbs. of force to open | 17 Lbs. | Adjust closers so doors do not require more than 5 pounds of force to open. | 1 | Labor | \$0 |

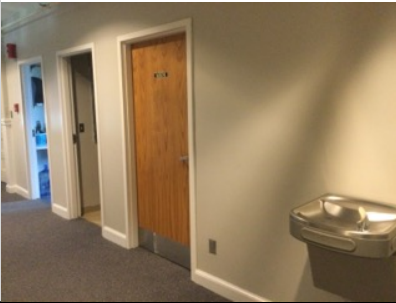
| ID | Location | Floor | Room | Element | Type | Photo | Issues | Current Measure | Recommendations | Quantity | Price | Cost Estimation |
|---|---|---|---|---|---|--|---|---|--|---|---|---|
| 21 | Men's Toilet Room | 3 | | Doors, Doorways, & Gates | Toilet Room | | Door requires > 5 lbs. of force to open | 18 Lbs. | Adjust closers so doors do not require more than 5 pounds of force to open. | 1 | Labor | \$0 |

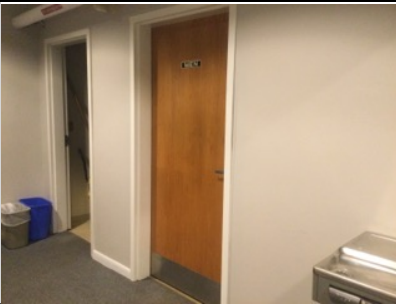
| ID | Location | Floor | Room | Element | Type | Photo | Issues | Current Measure | Recommendations | Quantity | Price | Cost Estimation |
|---|---|---|---|---|---|--|---|---|--|---|---|---|
| 22 | Men's Toilet Room | B | | Doors, Doorways, & Gates | Toilet Room | | Door requires > 5 lbs. of force to open | 14 Lbs. | Adjust closers so doors do not require more than 5 pounds of force to open. | 1 | Labor | \$0 |

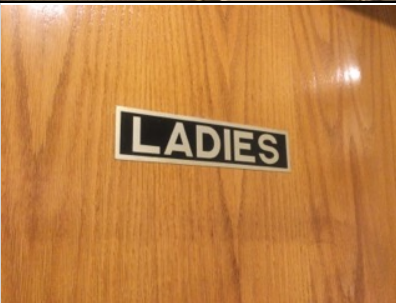
| ID | Location | Floor | Room | Element | Type | Photo | Issues | Current Measure | Recommendations | Quantity | Price | Cost Estimation |
|---|---|---|---|---|---|--|---|---|--|---|---|---|
| 23 | Women's Toilet Room | B | | Doors, Doorways, & Gates | Toilet Room | | Door requires > 5 lbs. of force to open | 15 Lbs. | Adjust closers so doors do not require more than 5 pounds of force to open. | 1 | Labor | \$0 |

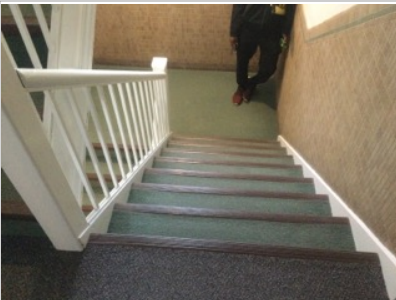
| ID | Location | Floor | Room | Element | Type | Photo | Issues | Current Measure | Recommendations | Quantity | Price | Cost Estimation |
|---|---|---|---|---|---|--|---|---|--|---|---|---|
| 24 | Egress Stair Facing South Street | 3 | | Stairways | Egress | | Handrail not provided on both sides | - | Provide handrails with 1 1/4" - 2" circular cross sections on side with no handrail.<br><br>(Cost based on a second compliant metal handrail on the side that does not have a metal handrail.) | 1 | 2220 | \$2220 |

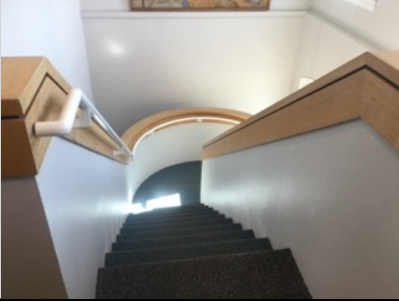
| ID | Location | Floor | Room | Element | Type | Photo | Issues | Current Measure | Recommendations | Quantity | Price | Cost Estimation |
|---|---|---|---|---|---|--|--|---|--|---|---|---|
| 25 | Egress Stair Near Accessible Entrance | 2 | | Stairways | Egress | | Handrails have non-compliant cross section | - | Provide handrails with 1 1/4" - 2" circular cross sections on side with just the wooden handrail.<br><br>(Cost based on a second compliant metal handrail on the side that does not have a metal handrail.) | 1 | 2220 | \$2220 |

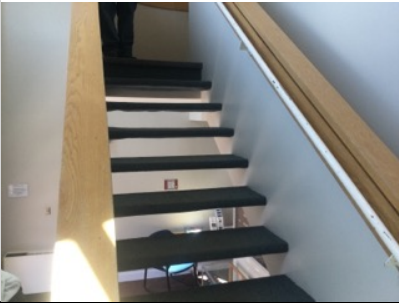
| ID | Location | Floor | Room | Element | Type | Photo | Issues | Current Measure | Recommendations | Quantity | Price | Cost Estimation |
|---|---|---|---|---|---|--|--|---|--|---|---|---|
| 26 | Front Stair Near Accessible Entrance | 2 | | Stairways | Egress | | Stair has open risers | - | Ensure stairs have closed risers. | 1 | 1320 | \$1320 |

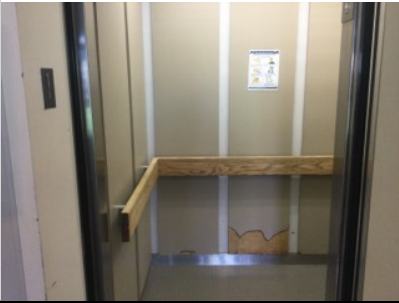
| ID | Location | Floor | Room | Element | Type | Photo | Issues | Current Measure | Recommendations | Quantity | Price | Cost Estimation |
|---|---|---|---|---|---|--|--|---|--|---|---|---|
| 27 | Elevator | 1 | | Elevator | Interior | | Tactile stars not provided at main entry level | - | Provide a tactile star on both sides of jambs at main floor. (Only one side has a tactile star at present.) At other floors, provide appropriate number. Provide a tactile star at the main floor on the control panel within the car. | 1 | 96 | \$96 |

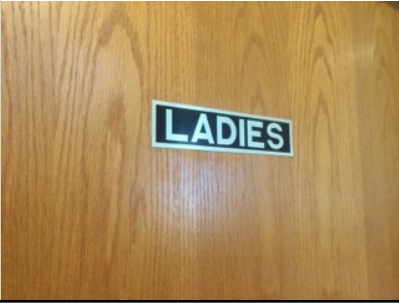
| ID | Location | Floor | Room | Element | Type | Photo | Issues | Current Measure | Recommendations | Quantity | Price | Cost Estimation |
|---|---|---|---|---|---|--|--|---|--|---|---|---|
| 28 | Women's Toilet Room | 1 | | Signage | Designation | | Raised characters not provided on sign<br>Braille not provided on sign<br>Sign not located on the latch side of the door | -<br>-<br>- | Provide text with raised characters duplicated in braille on sign.<br>Provide braille on sign.<br>Locate sign at permanent rooms alongside the door on the latch side. | 1 | 232 | \$232 |

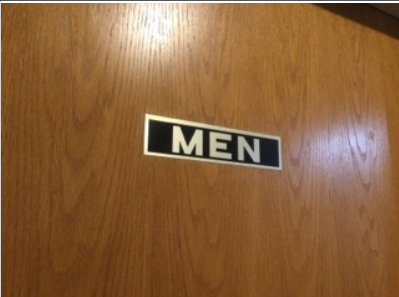
| ID | Location | Floor | Room | Element | Type | Photo | Issues | Current Measure | Recommendations | Quantity | Price | Cost Estimation |
|---|---|---|---|---|---|--|--|---|--|---|---|---|
| 29 | Men's Toilet Room | 1 | | Signage | Designation | | Raised characters not provided on sign<br>Braille not provided on sign<br>Sign not located on the latch side of the door | -<br>-<br>- | Provide text with raised characters duplicated in braille on sign.<br>Provide braille on sign.<br>Locate sign at permanent rooms alongside the door on the latch side. | 1 | 232 | \$232 |

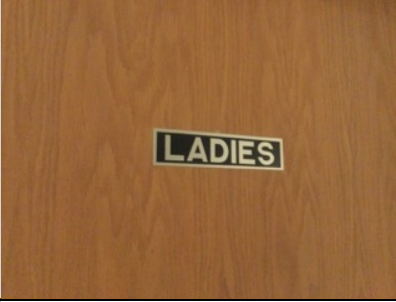
| ID | Location | Floor | Room | Element | Type | Photo | Issues | Current Measure | Recommendations | Quantity | Price | Cost Estimation |
|---|---|---|---|---|---|--|--|---|--|---|---|---|
| 30 | Women's Toilet Room | 3 | | Signage | Designation | | Raised characters not provided on sign<br>Braille not provided on sign<br>Sign not located on the latch side of the door | -<br>-<br>- | Provide text with raised characters duplicated in braille on sign.<br>Provide braille on sign.<br>Locate sign at permanent rooms alongside the door on the latch side. | 1 | 232 | \$232 |

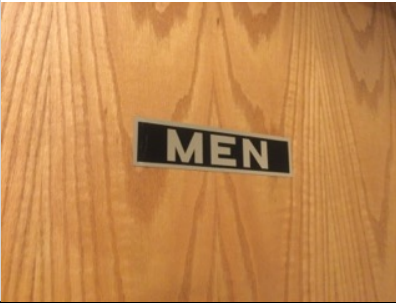
| ID | Location | Floor | Room | Element | Type | Photo | Issues | Current Measure | Recommendations | Quantity | Price | Cost Estimation |
|---|---|---|---|---|---|--|--|---|--|---|---|---|
| 31 | Men's Toilet Room | 3 | | Signage | Designation | | Raised characters not provided on sign<br>Braille not provided on sign<br>Sign not located on the latch side of the door | -<br>-<br>-<br>- | Provide text with raised characters duplicated in braille on sign.<br>Provide braille on sign.<br>Locate sign at permanent rooms alongside the door on the latch side. | 1 | 232 | \$232 |

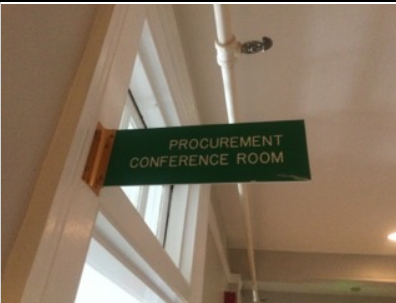
| ID | Location | Floor | Room | Element | Type | Photo | Issues | Current Measure | Recommendations | Quantity | Price | Cost Estimation |
|---|---|---|---|---|---|--|--|---|--|---|---|---|
| 32 | Procurement Conference Room | 3 | | Signage | Designation | | Raised characters not provided on sign<br>Braille not provided on sign<br>Sign not located on the latch side of the door | -<br>-<br>- | Provide text with raised characters duplicated in braille on sign.<br>Locate sign at permanent rooms alongside the door on the latch side. | 1 | 232 | \$232 |

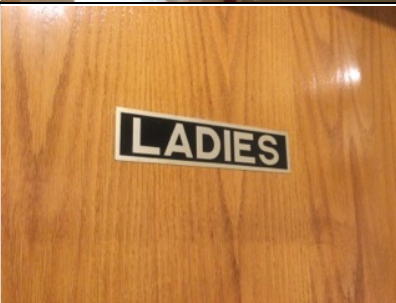
| ID | Location | Floor | Room | Element | Type | Photo | Issues | Current Measure | Recommendations | Quantity | Price | Cost Estimation |
|---|---|---|---|---|---|--|--|---|--|---|---|---|
| 33 | Women's Toilet Room | B | | Signage | Designation | | Raised characters not provided on sign<br>Braille not provided on sign<br>Sign not located on the latch side of the door | -<br>-<br>- | Provide text with raised characters duplicated in braille on sign.<br>Provide braille on sign.<br>Locate sign at permanent rooms alongside the door on the latch side. | 1 | 232 | \$232 |

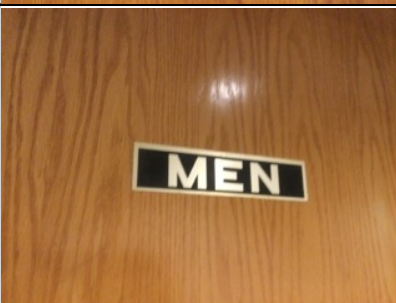
| ID | Location | Floor | Room | Element | Type | Photo | Issues | Current Measure | Recommendations | Quantity | Price | Cost Estimation |
|---|---|---|---|---|---|--|--|---|--|---|---|---|
| 34 | Men's Toilet Room | B | | Signage | Designation | | Raised characters not provided on sign<br>Braille not provided on sign<br>Sign not located on the latch side of the door | -<br>-<br>- | Provide text with raised characters duplicated in braille on sign.<br>Provide braille on sign.<br>Locate sign at permanent rooms alongside the door on the latch side. | 1 | 232 | \$232 |

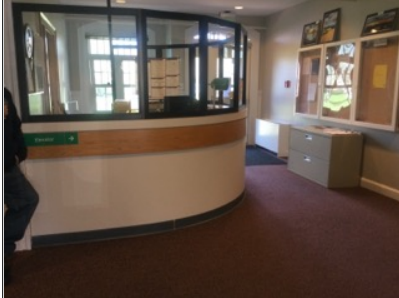
| ID | Location | Floor | Room | Element | Type | Photo | Issues | Current Measure | Recommendations | Quantity | Price | Cost Estimation |
|---|---|---|---|---|---|--|---|---|---|---|---|---|
| 35 | Reception | 1 | | Service Counter | N/A | | Counter > 36" high | 42" | Provide a counter that is 36" max. above the ground or finished floor. | 1 | 880 | \$880 |

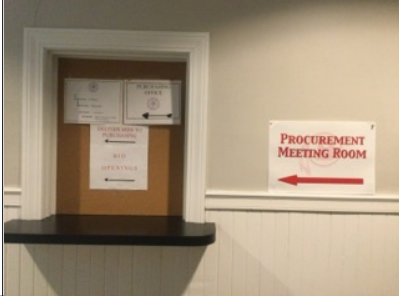
| ID | Location | Floor | Room | Element | Type | Photo | Issues | Current Measure | Recommendations | Quantity | Price | Cost Estimation |
|---|---|---|---|---|---|--|---|---|---|---|---|---|
| 36 | Administrative Services | 3 | | Service Counter | N/A | | Counter > 36" high | - | Provide a counter that is 36" max. above the ground or finished floor. | 1 | 880 | \$880 |

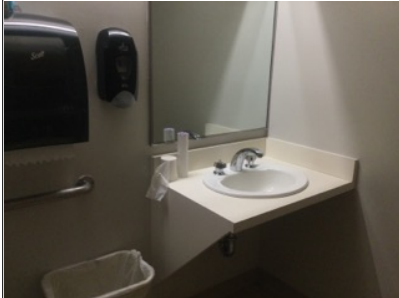
| ID | Location | Floor | Room | Element | Type | Photo | Issues | Current Measure | Recommendations | Quantity | Price | Cost Estimation |
|---|---|---|---|---|---|--|---|---|---|---|---|---|
| 37 | Women's Toilet Room | 1 | | Lavatory | N/A | | Plumbing underneath is exposed | - | Insulate or otherwise configure pipes to prevent contact for at least one lavatory. | 1 | 92 | \$92 |

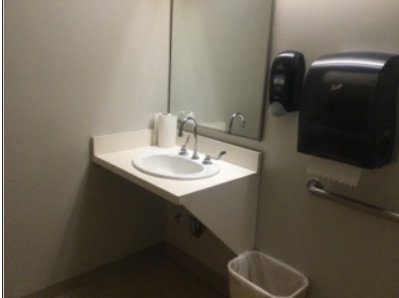
| ID | Location | Floor | Room | Element | Type | Photo | Issues | Current Measure | Recommendations | Quantity | Price | Cost Estimation |
|---|---|---|---|---|---|--|---|---|---|---|---|---|
| 38 | Men's Toilet Room | 1 | | Lavatory | N/A | | Plumbing underneath is exposed | - | Insulate or otherwise configure pipes to prevent contact for at least one lavatory. | 1 | 92 | \$92 |

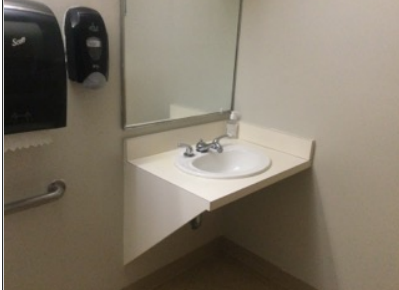
| ID | Location | Floor | Room | Element | Type | Photo | Issues | Current Measure | Recommendations | Quantity | Price | Cost Estimation |
|---|---|---|---|---|---|--|---|---|---|---|---|---|
| 39 | Women's Toilet Room | 3 | | Lavatory | N/A | | Plumbing underneath is exposed | - | Insulate or otherwise configure pipes to prevent contact for at least one lavatory. | 1 | 92 | \$92 |

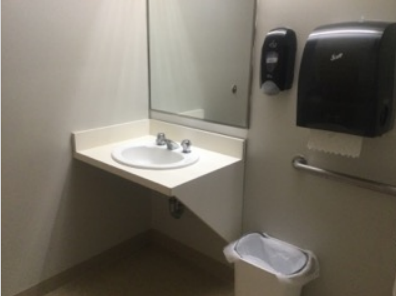
| ID | Location | Floor | Room | Element | Type | Photo | Issues | Current Measure | Recommendations | Quantity | Price | Cost Estimation |
|---|---|---|---|---|---|--|---|---|--|---|---|---|
| 40 | Men's Toilet Room | 3 | | Lavatory | N/A | | Plumbing underneath is exposed | - | Insulate or otherwise configure pipes to prevent contact for at least one lavatory. | 1 | 92 | \$92 |

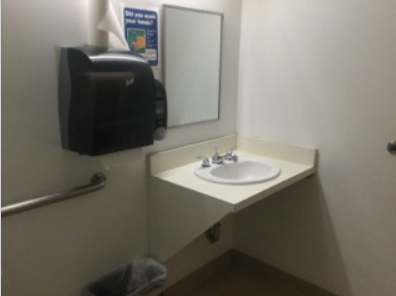
| ID | Location | Floor | Room | Element | Type | Photo | Issues | Current Measure | Recommendations | Quantity | Price | Cost Estimation |
|---|---|---|---|---|---|--|---|---|--|---|---|---|
| 41 | Women's Toilet Room | B | | Lavatory | N/A | | Plumbing underneath is exposed | - | Insulate or otherwise configure pipes to prevent contact for at least one lavatory. | 1 | 92 | \$92 |

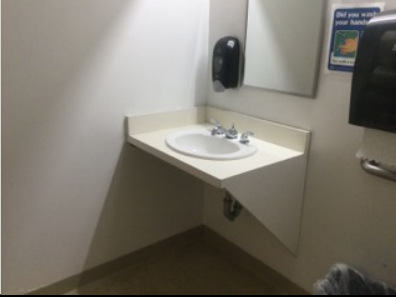
| ID | Location | Floor | Room | Element | Type | Photo | Issues | Current Measure | Recommendations | Quantity | Price | Cost Estimation |
|---|---|---|---|---|---|--|---|---|--|---|---|---|
| 42 | Men's Toilet Room | B | | Lavatory | N/A | | Plumbing underneath is exposed | - | Insulate or otherwise configure pipes to prevent contact for at least one lavatory. | 1 | 92 | \$92 |

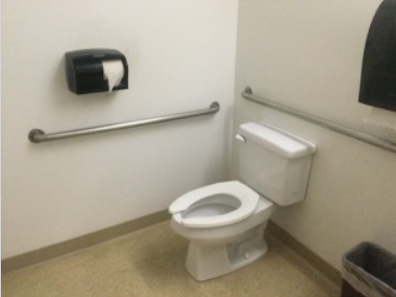
| ID | Location | Floor | Room | Element | Type | Photo | Issues | Current Measure | Recommendations | Quantity | Price | Cost Estimation |
|---|---|---|---|---|---|--|---|---|--|---|---|---|
| 43 | Women's Toilet Room | B | | Single-User Toilet | N/A | | Toilet seat < 17" or > 19" high<br>Flush control not on open side<br>Centerline < or > 18" (MAAB)<br>Side or rear grab bar < 33" or > 36" high<br>Toilet paper dispenser is not compliant | 16.2"<br>-<br>20.3"<br>31"<br>- | Install a toilet with a seat between 17"- 19" high above the finished floor.<br>Relocate the flush control to the open side.<br>Relocate toilet so that the centerline is 18" from the side wall.<br>Mount grab bars 33"- 36" above the floor.<br>Relocate toilet paper to under the grab bar.<br>Relocate paper towel dispenser so it is not above the grab bar. | 1 | 4304 | \$4304 |

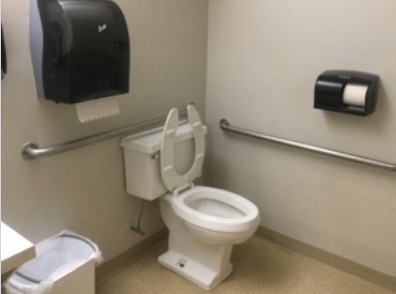
| ID | Location | Floor | Room | Element | Type | Photo | Issues | Current Measure | Recommendations | Quantity | Price | Cost Estimation |
|---|---|---|---|---|---|--|---|---|--|---|---|---|
| 44 | Men's Toilet Room | 3 | | Single-User Toilet | N/A | | Toilet seat < 17" or > 19" high<br>Centerline < or > 18" (MAAB)<br>Side or rear grab bar < 33" or > 36" high<br>Toilet paper dispenser is not compliant | 21.1"<br>20"<br>30.3"<br>- | Install a toilet with a seat between 17"- 19" high above the finished floor.<br>Relocate toilet so that the centerline is 18" from the side wall.<br>Mount grab bars 33"- 36" above the floor.<br>Relocate toilet paper so that it is 24" min. high, located under the grab bar, and between 7" and 9" from the front of the toilet.<br>Relocate paper towel dispenser from above grab | 1 | 4326 | \$4326 |

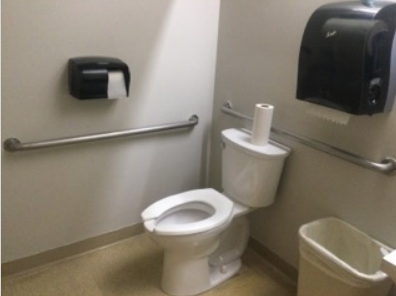
| ID | Location | Floor | Room | Element | Type | Photo | Issues | Current Measure | Recommendations | Quantity | Price | Cost Estimation |
|---|---|---|---|---|---|--|--|---|---|---|---|---|
| 45 | Women's Toilet Room | 1 | | Single-User Toilet | N/A | | Flush control not on open side<br>Centerline < 16" or > 18"<br>Toilet paper dispenser is not compliant | -<br>21.3"<br>- | Relocate the flush control to the open side.<br>Relocate toilet so that the centerline is 18" from the side wall.<br>Relocate toilet paper so that it is 24" min. high, located under the grab bar, and between 7" and 9" from the front of the toilet.<br>Relocate the paper towel dispenser so that it is not above the grab bar. | 1 | 3908 | \$3908 |

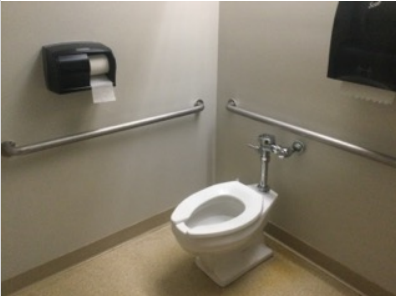
| ID | Location | Floor | Room | Element | Type | Photo | Issues | Current Measure | Recommendations | Quantity | Price | Cost Estimation |
|---|---|---|---|---|---|--|--|---|---|---|---|---|
| 46 | Women's Toilet Room | 3 | | Single-User Toilet | N/A | | Flush control not on open side<br>Centerline < or > 18" (MAAB)<br>Side or rear grab bar < 33" or > 36" high<br>Toilet paper dispenser is not compliant | -<br>20"<br>30.8"<br>- | Relocate the flush control to the open side.<br>Relocate toilet so that the centerline is 18" from the side wall.<br>Mount grab bars 33"- 36" above the floor.<br>Relocate toilet paper so that it is 24" min. high, located under the grab bar, and between 7" and 9" from the front of the toilet.<br>Relocate paper towel dispenser so it is not above the grab bar. | 1 | 4700 | \$4700 |

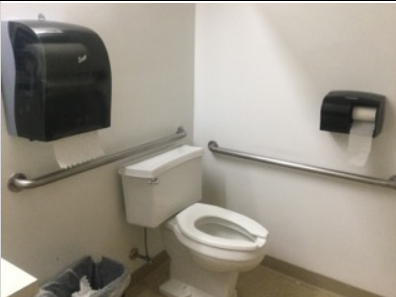
| ID | Location | Floor | Room | Element | Type | Photo | Issues | Current Measure | Recommendations | Quantity | Price | Cost Estimation |
|---|---|---|---|---|---|--|--|---|---|---|---|---|
| 47 | Men's Toilet Room | B | | Single-User Toilet | N/A | | Side or rear grab bar < 33" or > 36" high<br>Toilet paper dispenser is not compliant | 31.5"<br>- | Mount side grab bar 33"- 36" above the floor.<br>Relocate toilet paper so that it is 24" min. high, located under the grab bar, and between 7" and 9" from the front of the toilet.<br>Relocate paper towel dispenser so it is not above the grab bar. | 1 | 1102 | \$1102 |

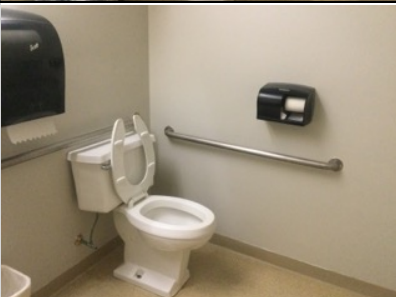
| ID | Location | Floor | Room | Element | Type | Photo | Issues | Current Measure | Recommendations | Quantity | Price | Cost Estimation |
|---|---|---|---|---|---|--|--|---|---|---|---|---|
| 48 | Men's Toilet Room | 1 | | Single-User Toilet | N/A | | Toilet paper dispenser is not compliant | - | Relocate toilet paper so that it is 24" min high, located under the grab bar, and between 7" and 9" from the front of the toilet.<br>Relocate paper towel dispenser so that it is not above the grab bar. | 1 | 706 | \$706 |

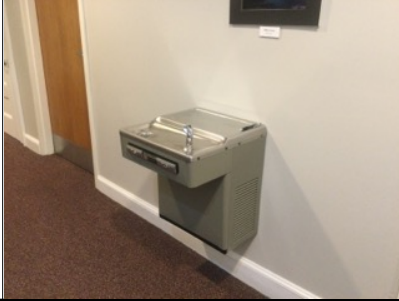
| ID | Location | Floor | Room | Element | Type | Photo | Issues | Current Measure | Recommendations | Quantity | Price | Cost Estimation |
|---|--|---|---|---|---|--|--|---|--|---|---|---|
| 50 | Drinking Fountain | 1 | | Drinking Fountains | Low | | No drinking fountain provided for standing users | - | Provide an additional drinking fountain for standing users or install a Hi-Lo drinking fountain. | 1 | 4028 | \$4028 |

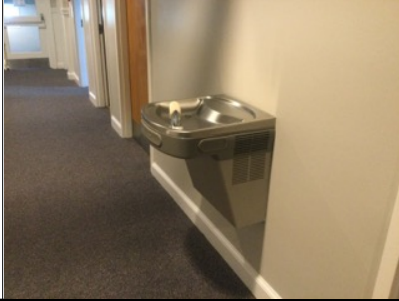
| ID | Location | Floor | Room | Element | Type | Photo | Issues | Current Measure | Recommendations | Quantity | Price | Cost Estimation |
|---|--|---|---|---|---|--|--|---|--|---|---|---|
| 51 | Drinking Fountain | 3 | | Drinking Fountains | High | | No drinking fountain provided for seated users | - | Provide an additional drinking fountain for seated users or install a Hi-Lo drinking fountain. | 1 | 4028 | \$4028 |

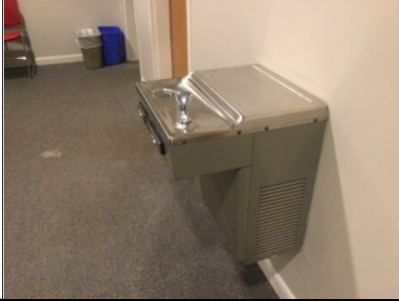
| ID | Location | Floor | Room | Element | Type | Photo | Issues | Current Measure | Recommendations | Quantity | Price | Cost Estimation |
|---|--|---|---|---|---|--|--|---|--|---|---|---|
| 52 | Fountain | B | | Drinking Fountains | High | | No drinking fountain provided for seated users | - | Provide an additional drinking fountain for seated users or install a Hi-Lo drinking fountain. | 1 | 4028 | \$4028 |

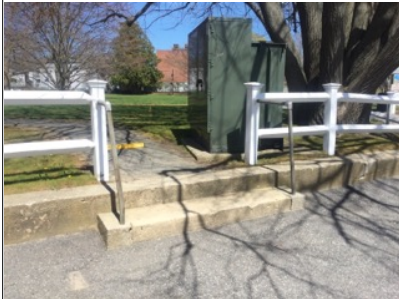
| ID | Location | Floor | Room | Element | Type | Photo | Issues | Current Measure | Recommendations | Quantity | Price | Cost Estimation |
|---|--|---|---|---|---|--|--|---|--|---|---|---|
| 53 | Left Path to Car Parking - Outside Entrance/ Exit From Village Green | Ext. | | Exterior Stair | N/A | | | | Recommend that the sloped bottom railing extends one tread depth minimum beyond last riser nosing in same direction as stair flight. | 1 | - | \$0 |

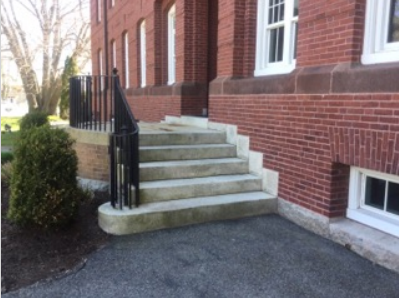
| ID | Location | Floor | Room | Element | Type | Photo | Issues | Current Measure | Recommendations | Quantity | Price | Cost Estimation |
|---|---|---|---|---|---|--|---|---|---|---|---|---|
| 54 | Right Stair - Entrance/ Exit From Village Green | Ext. | | Exterior Stair | N/A | | | | Recommend providing railings on both sides of the stairs. | 1 | - | \$0 |

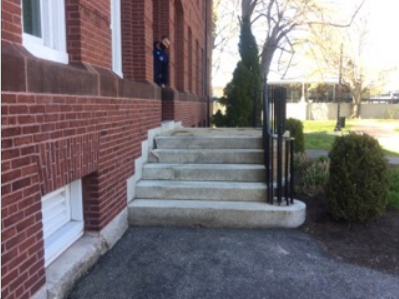
| ID | Location | Floor | Room | Element | Type | Photo | Issues | Current Measure | Recommendations | Quantity | Price | Cost Estimation |
|---|---|---|---|---|---|--|---|---|---|---|---|---|
| 55 | Left Stair - Entrance/ Exit From Village Green | Ext. | | Exterior Stair | N/A | | | | Recommend providing railings on both sides of the stairs. | 1 | - | \$0 |
