Luke's Love Playground

Town of Barnstable
ADA Transition Plan

September 2021

Institute for Human Centered Design

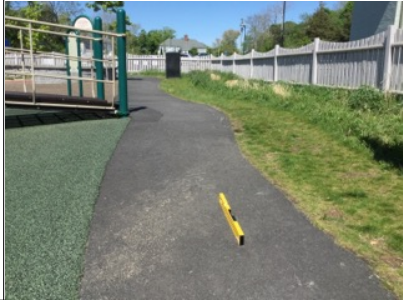
ID	Location	Floor	Room	Element	Type	Photo	Issues	Current Measure	Recommendations	Quantity	Price	Cost Estimation
Approach and Entrance												
Exterior Access Route												
1	Route to Left of Entrance Next to Building	Ext.		Exterior Access Route	Walkway

Cross slope > 1:50 (2.00%) Running slope > 1:20 (5%)	3.5% 6.5%	Reduce cross slope to be no steeper than 1:50 (2.00%). Reduce running slope to be no steeper than 1:20 (5%).	1	-	\$0
2	Little Library	Ext.		Exterior Access Route	Exterior

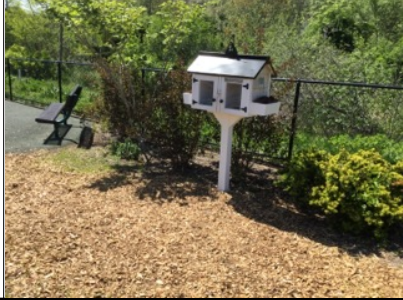
Accessible route not provided	-	Ensure an accessible route is provided.	1	Labor	\$0
Entrance												
3	Exit	Ext.		Entrance	Gate

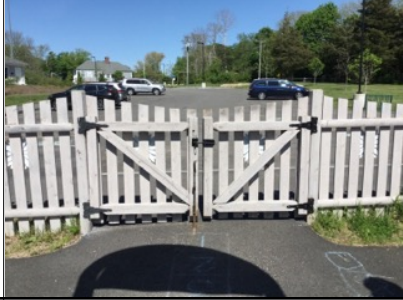
Hardware not operable with a closed fist	-	Provide hardware that can be operable with one hand and not require tight grasping, pinching, or twisting of the wrist.	1	484	\$484
Best Practice												
Detectable Warning												
4	Route From Parking Lot to Playground Entrance	Ext.		Detectable Warning	N/A

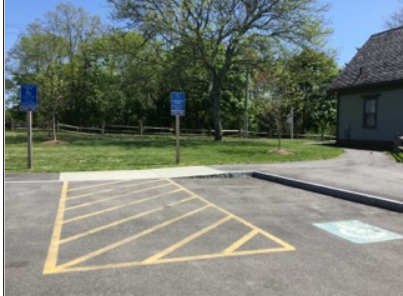
Recommend providing a detectable warning at this location.	1	-	\$0

- Recommend providing some benches with backs and some with arms around the playground.
- Recommend providing detectable warnings at the curb ramp located near the accessible parking space.
